Effects of bank vegetation in waterways with special reference to bank erosion, shear strength, root density and channel hydraulics

**Effects of Bank Vegetation in Waterways with Special
Reference to Bank Erosion, Shear Strength, Root Density and
Channel Hydraulics**

**A thesis submitted to the Open University
for the Degree of Doctor of Philosophy
Biology Department
September 1992**

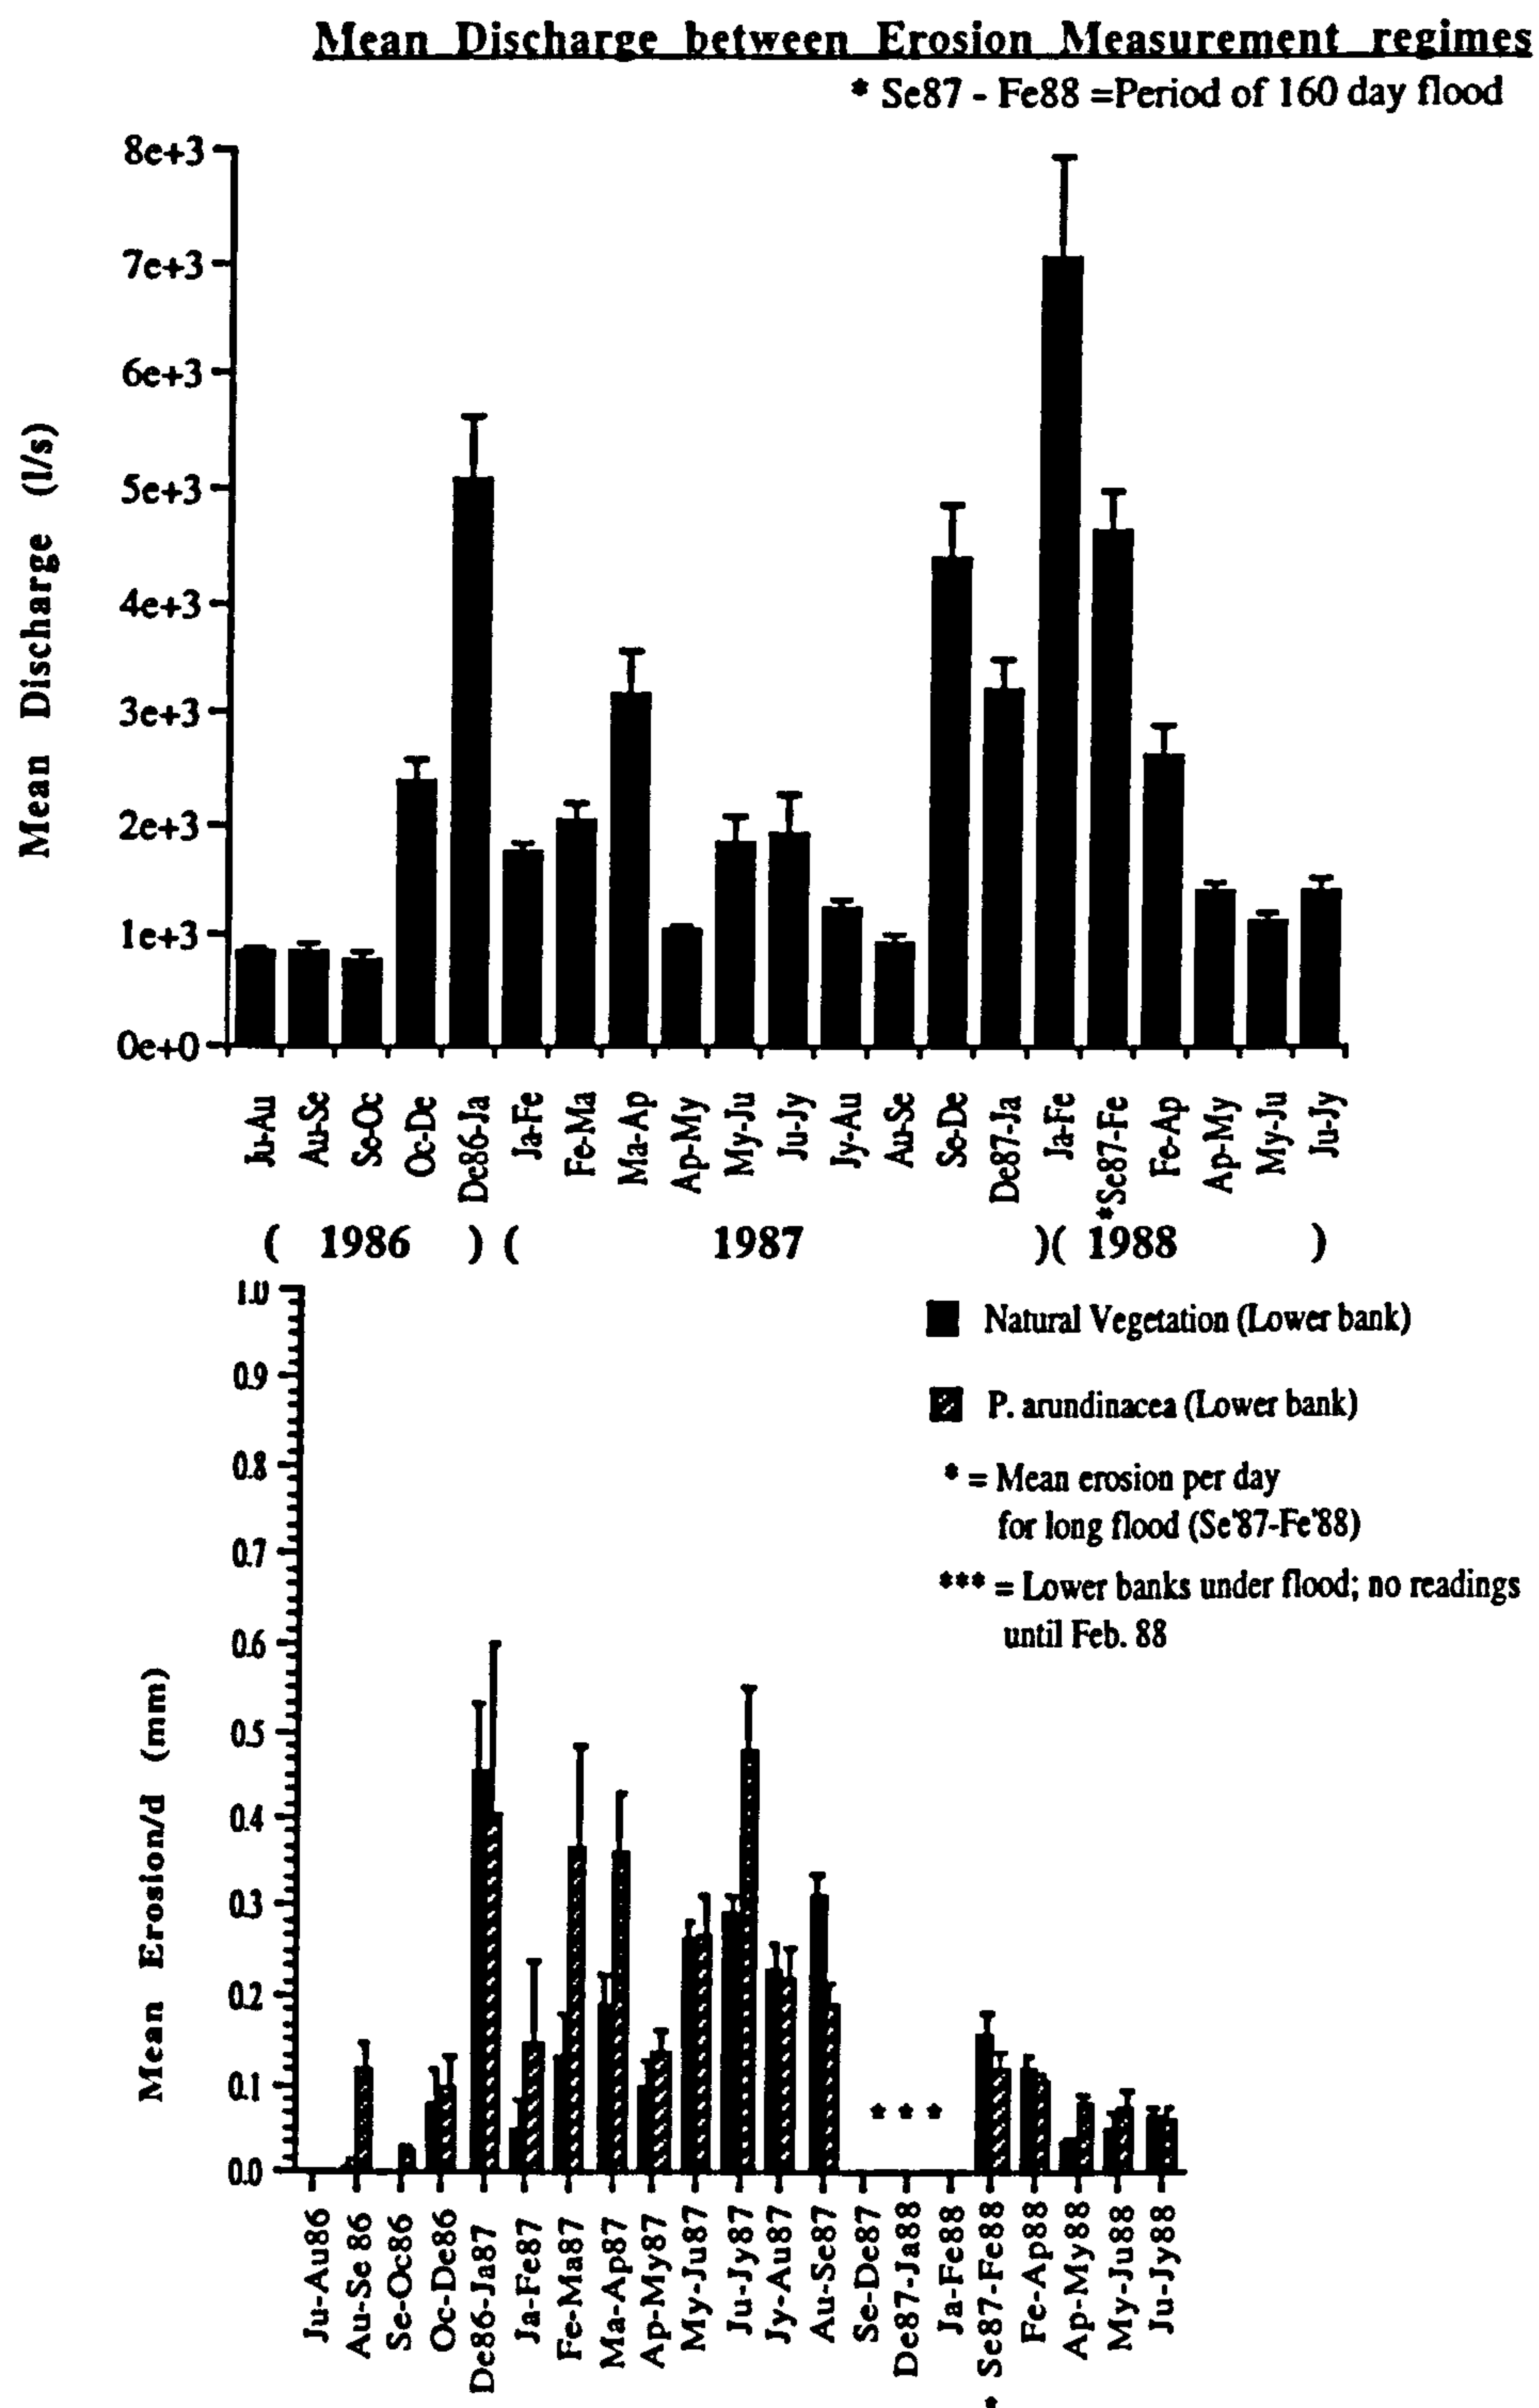
Fig. 4.7 : Comparison of Erosion: Natural vegetation Vs. P.arundinacea (Lower Banks)

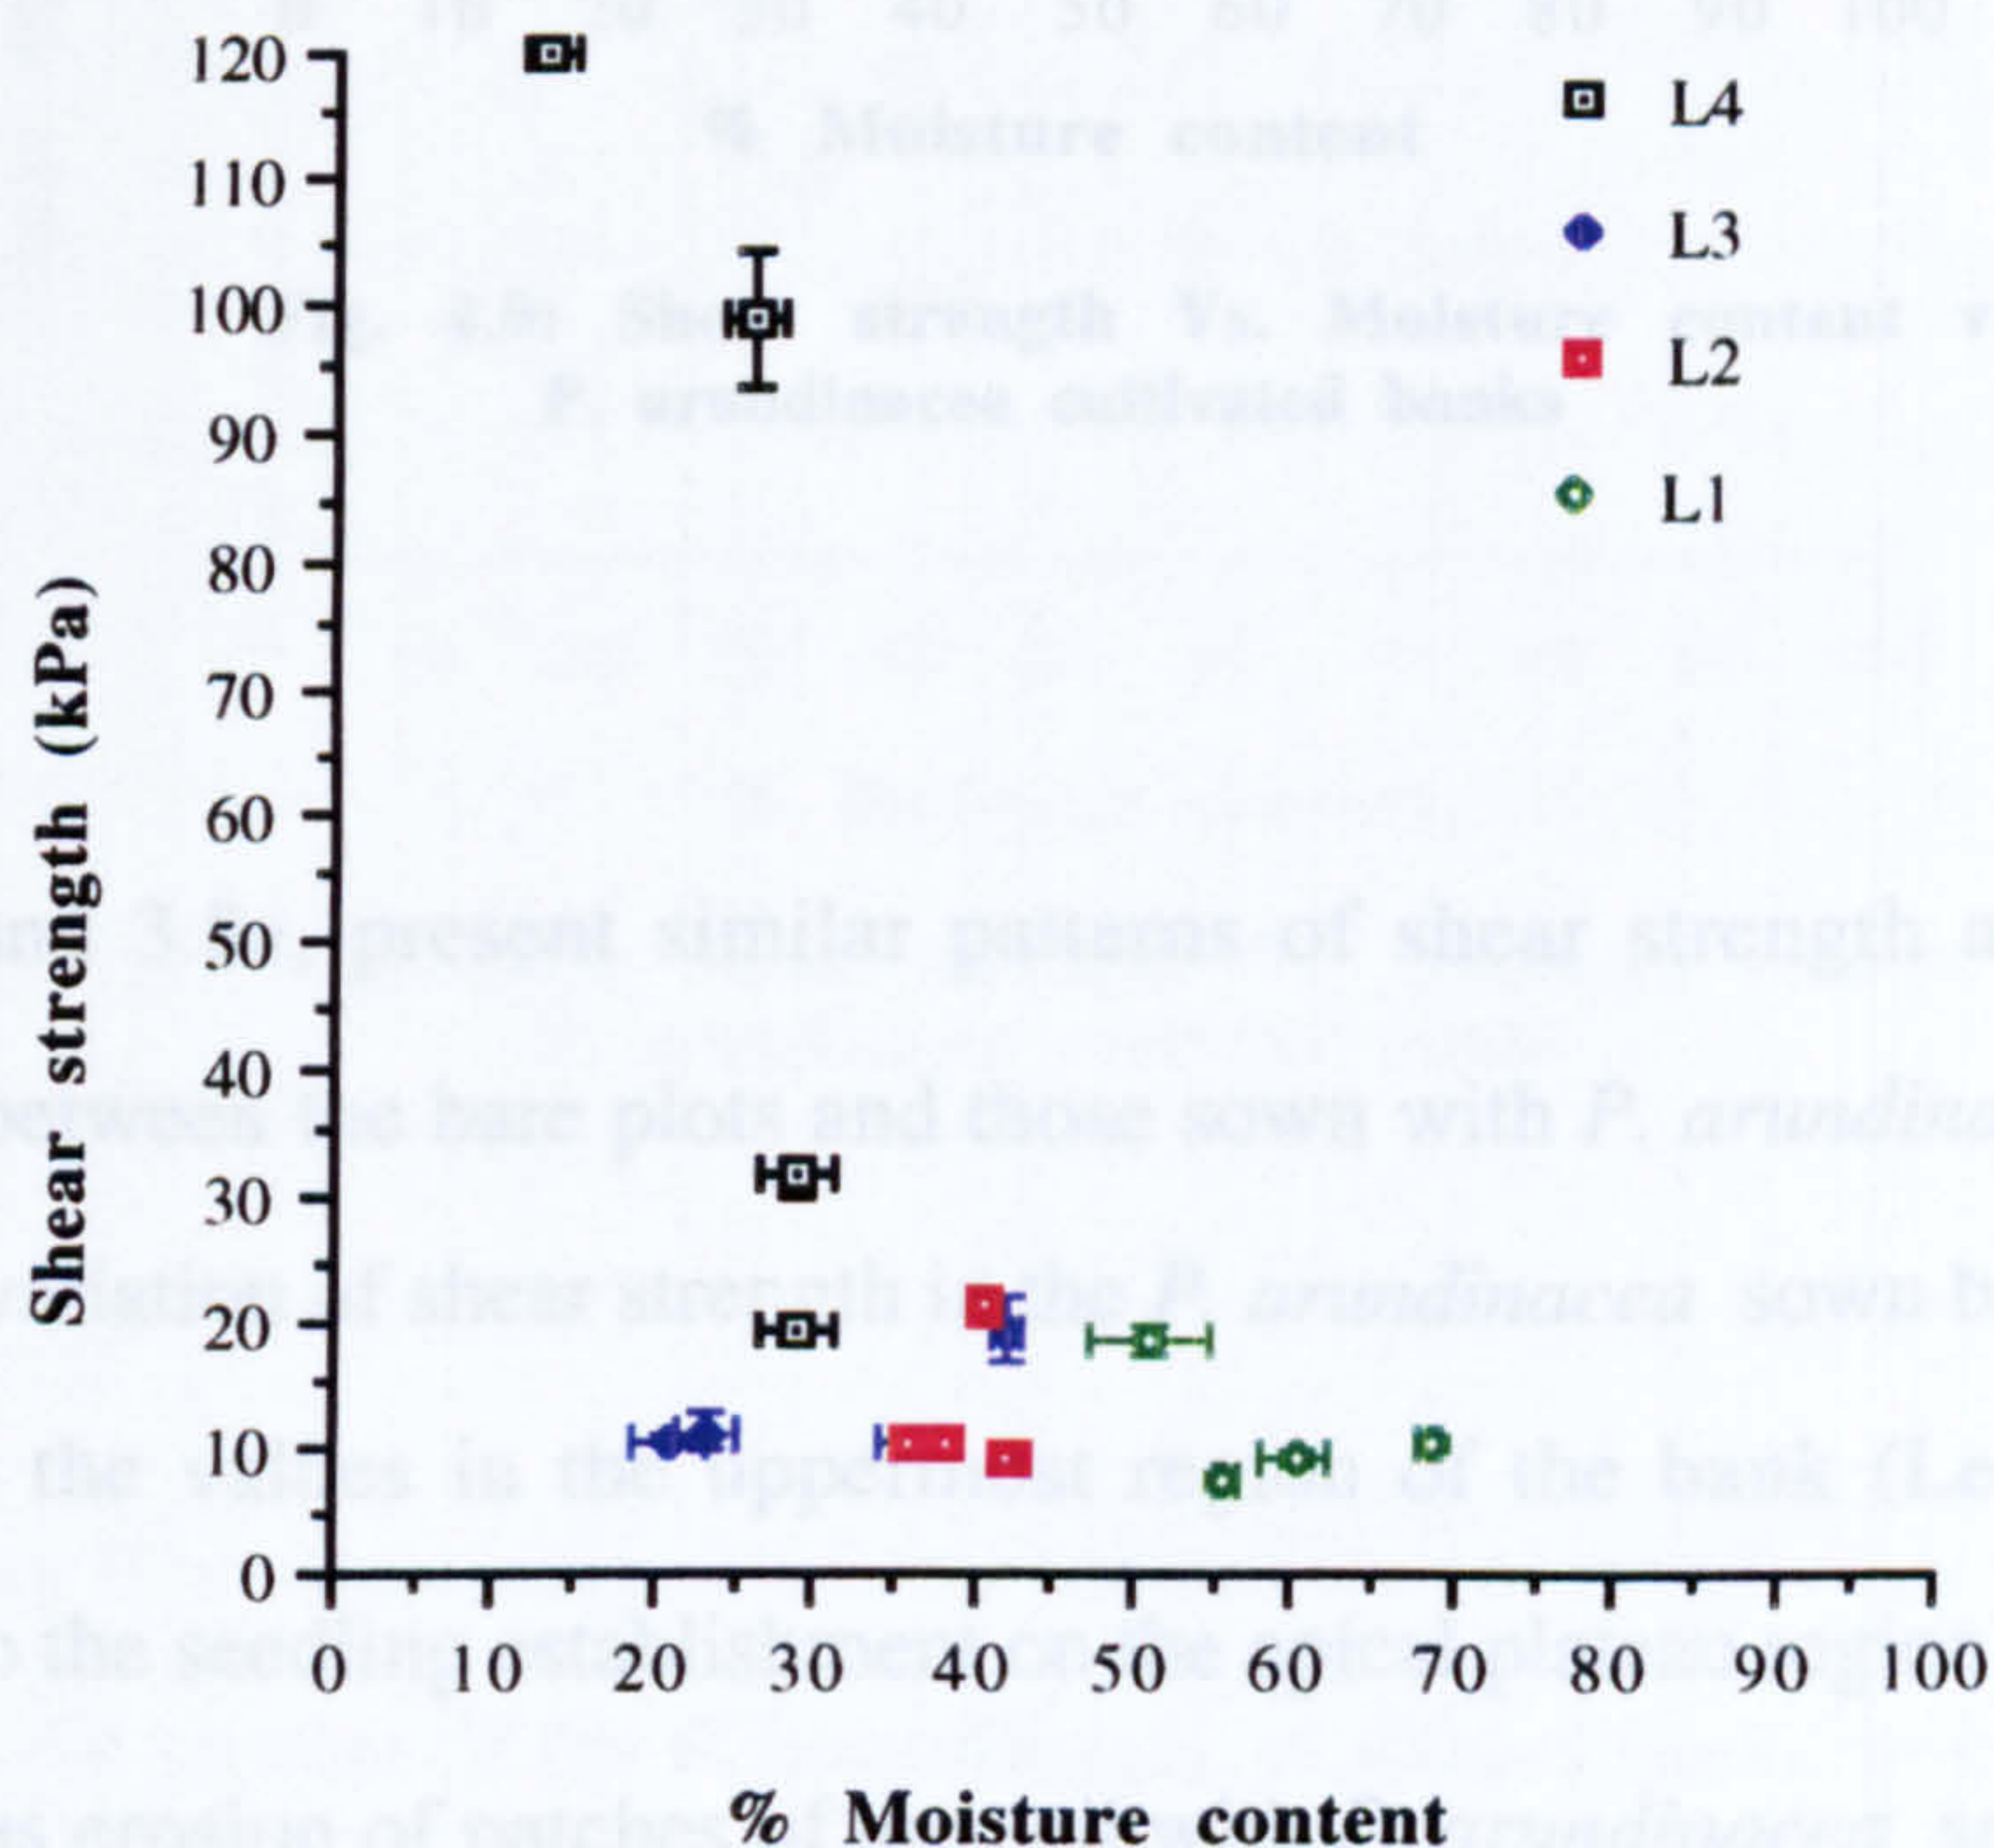
Fig. 4.8: Shear strength Vs. Moisture content variations (August 1986) *P. arundinacea* cultivated bank (6 weeks after seeding)

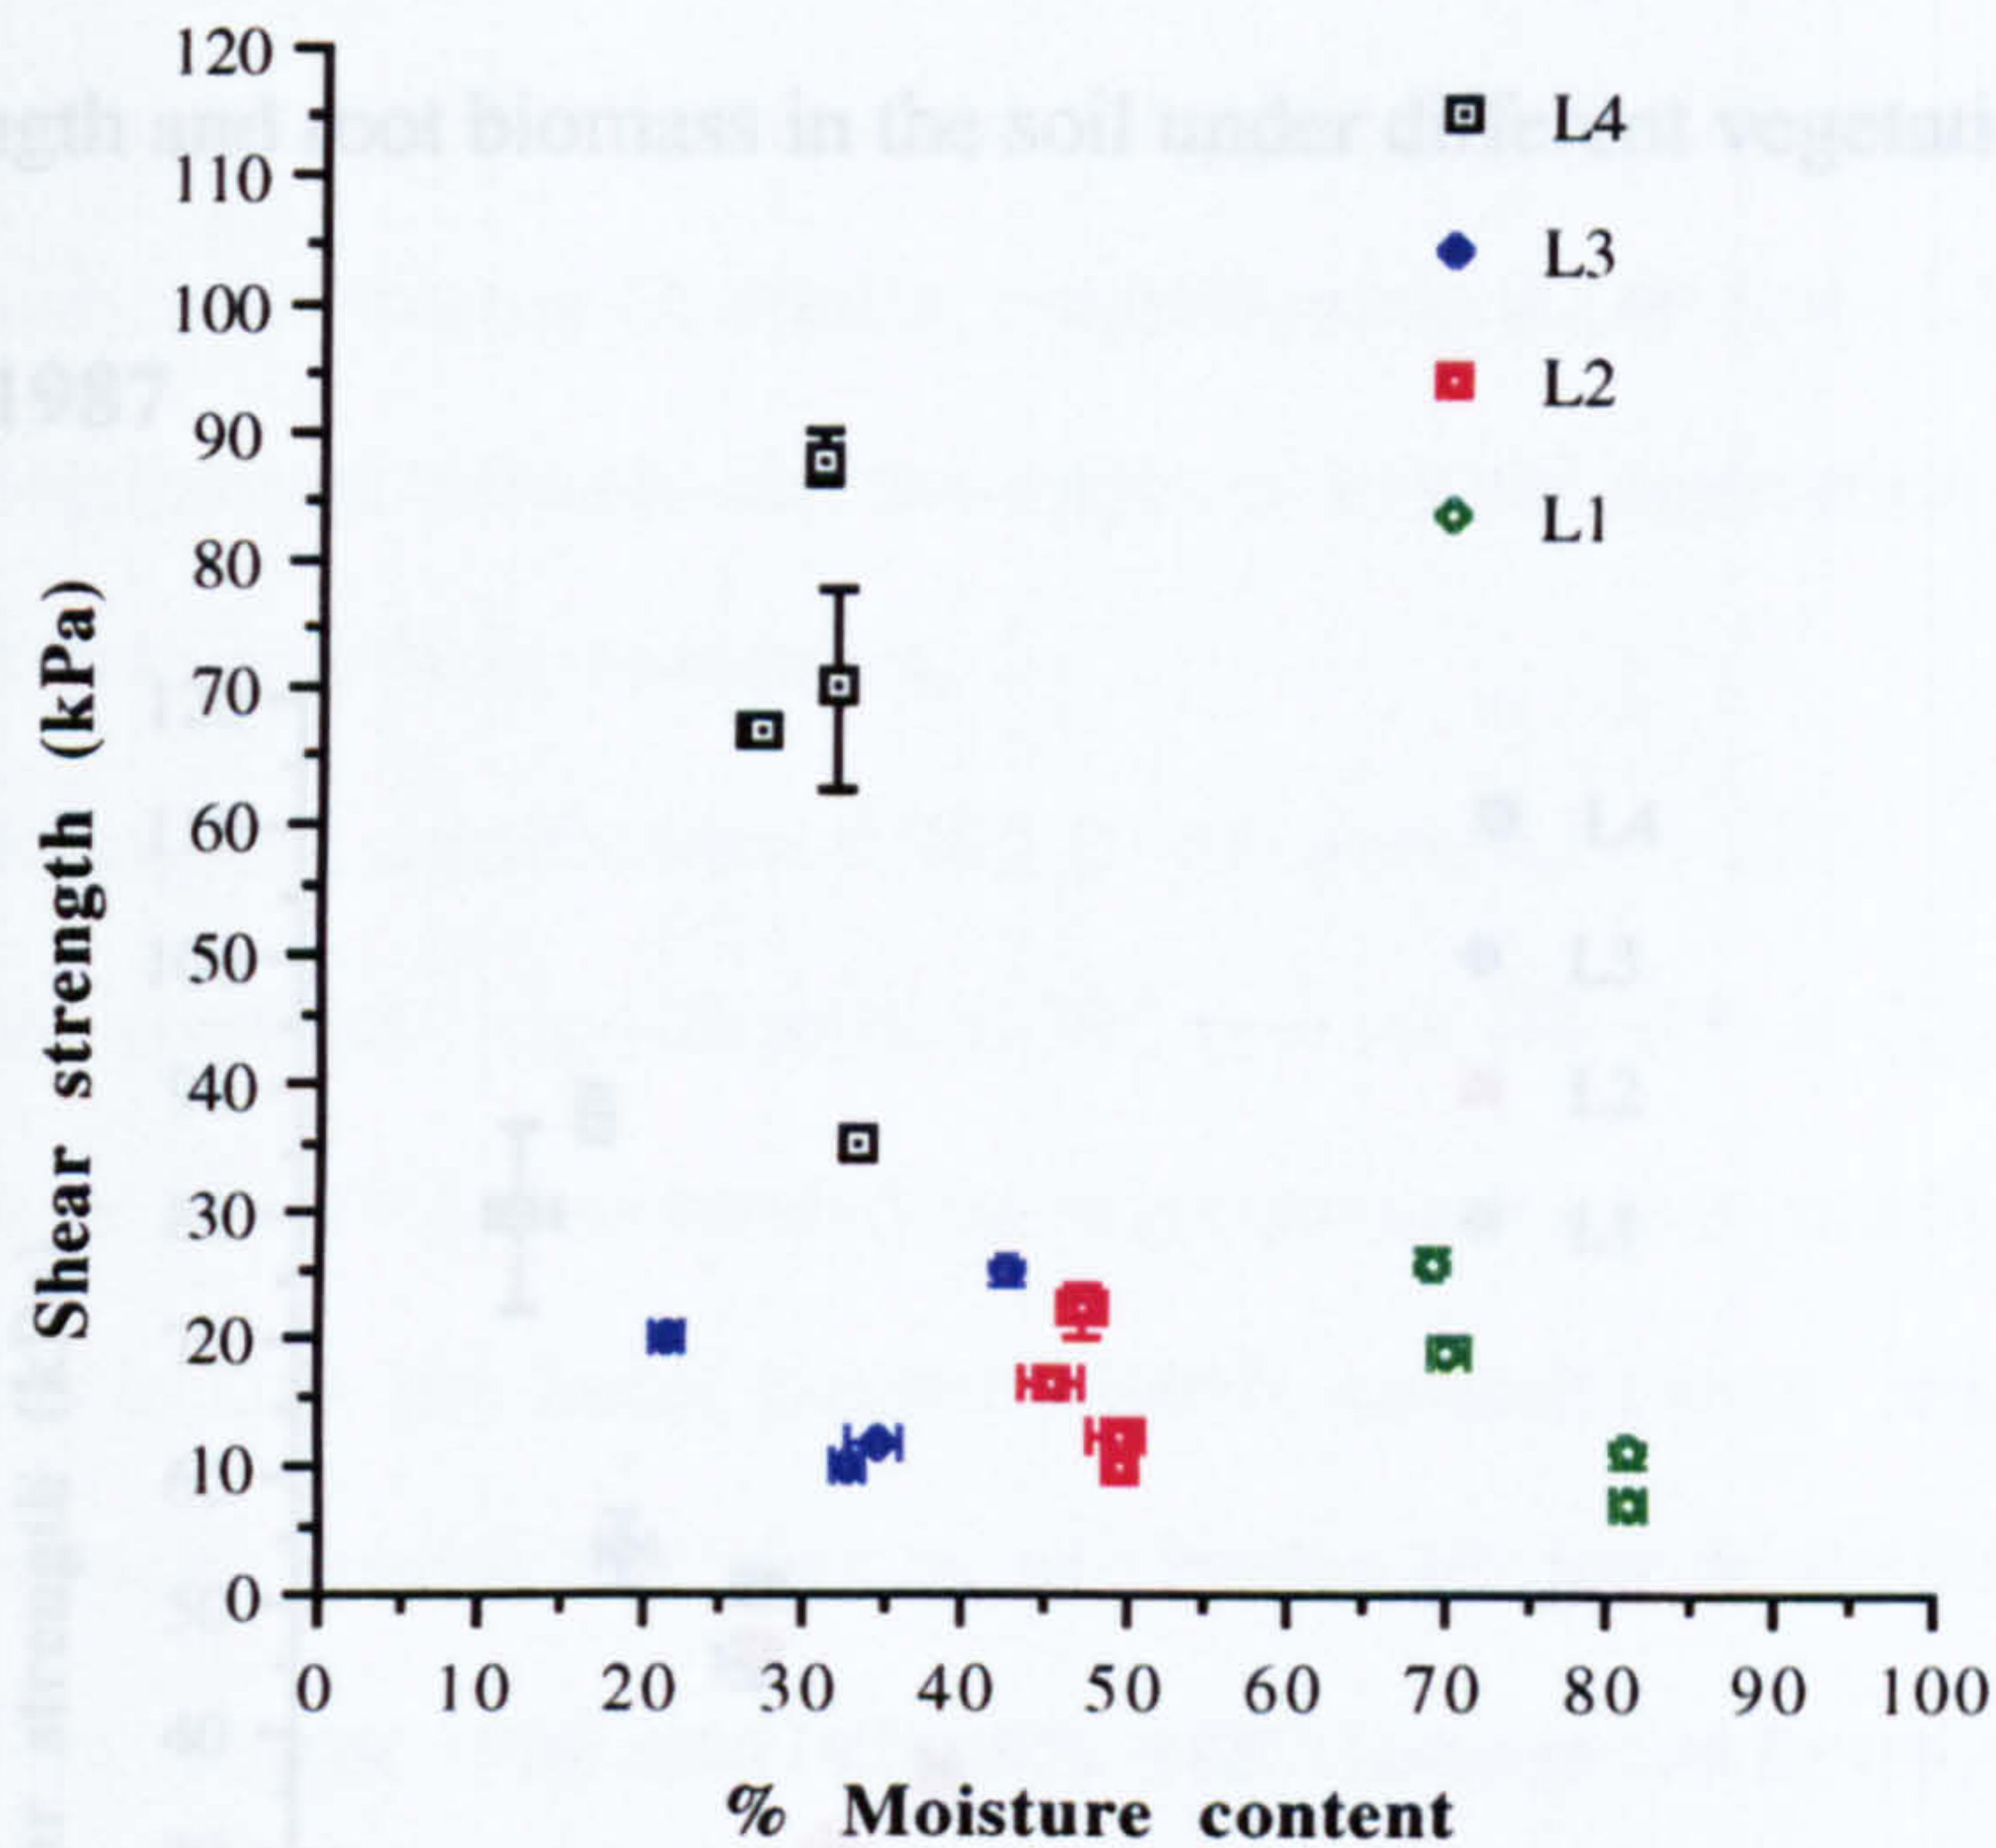
Fig. 4.9: Shear strength Vs. Moisture content variations (February 1987)
P. arundinacea cultivated banks

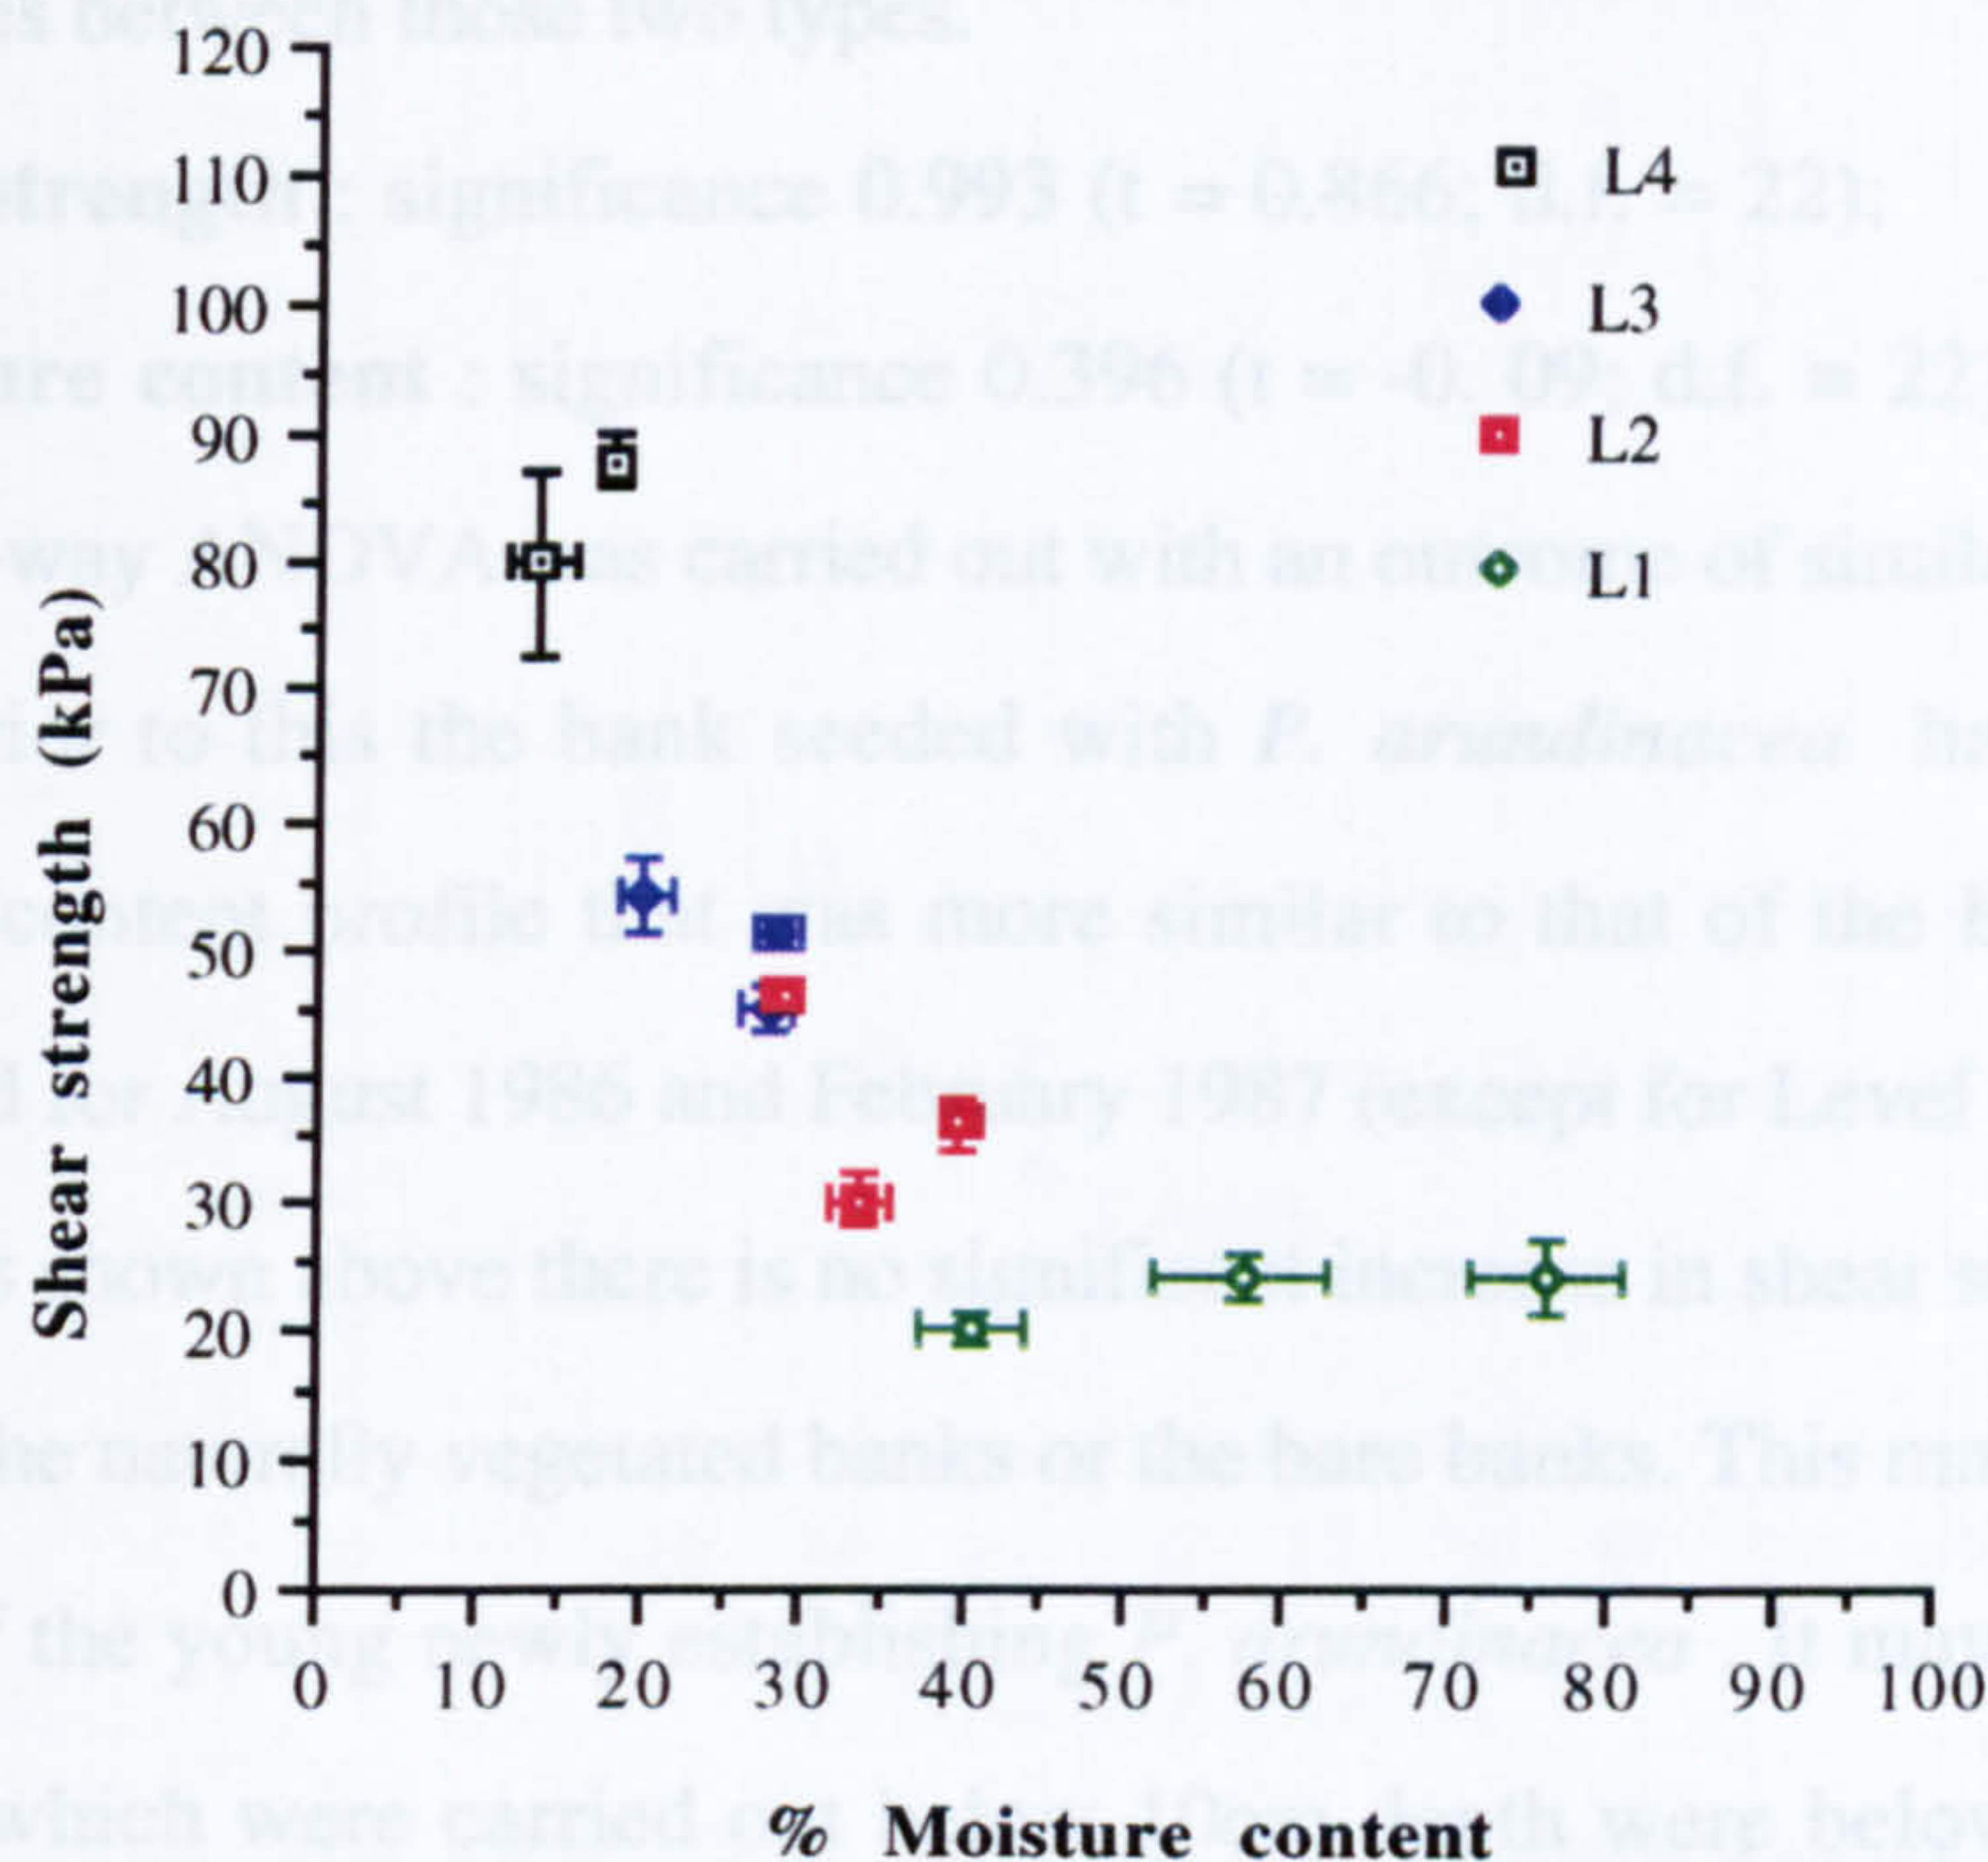
Fig. 4.10: Shear strength Vs. Moisture content variations (August 1987) *P. arundinacea* cultivated banks

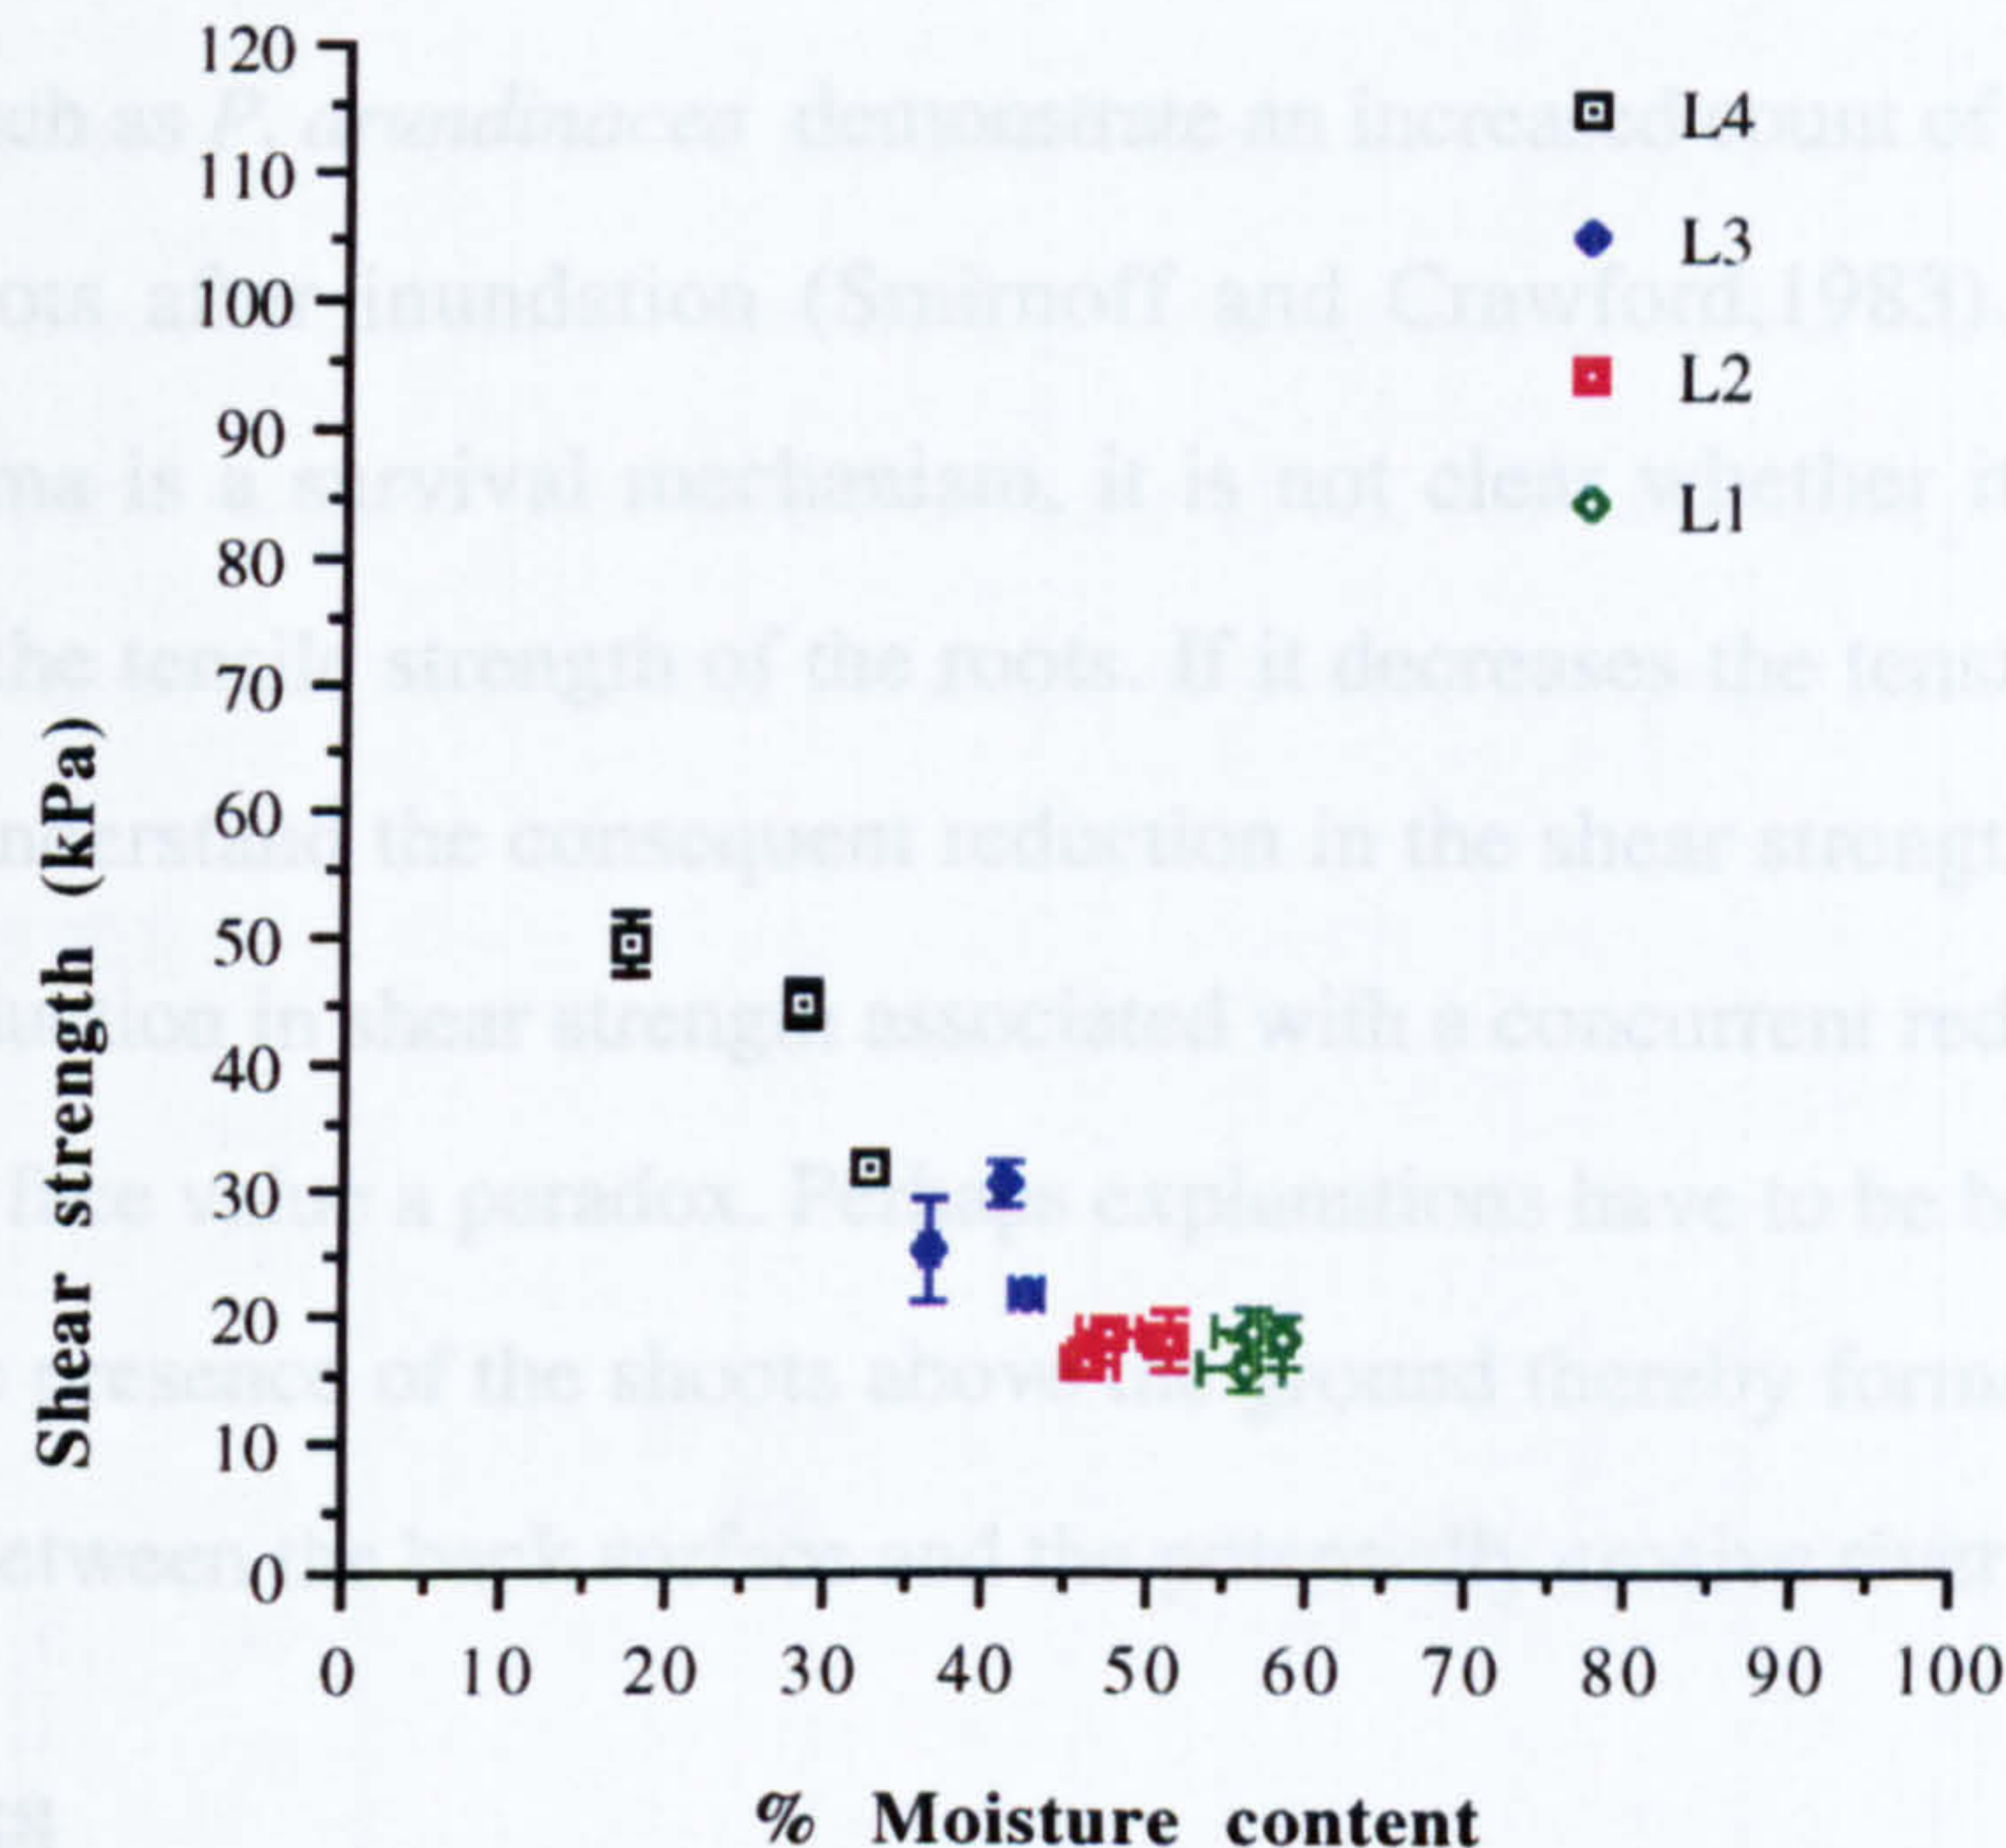
Fig. 4.11: Shear strength Vs. Moisture content variations (February 1988) *P. arundinacea* cultivated banks

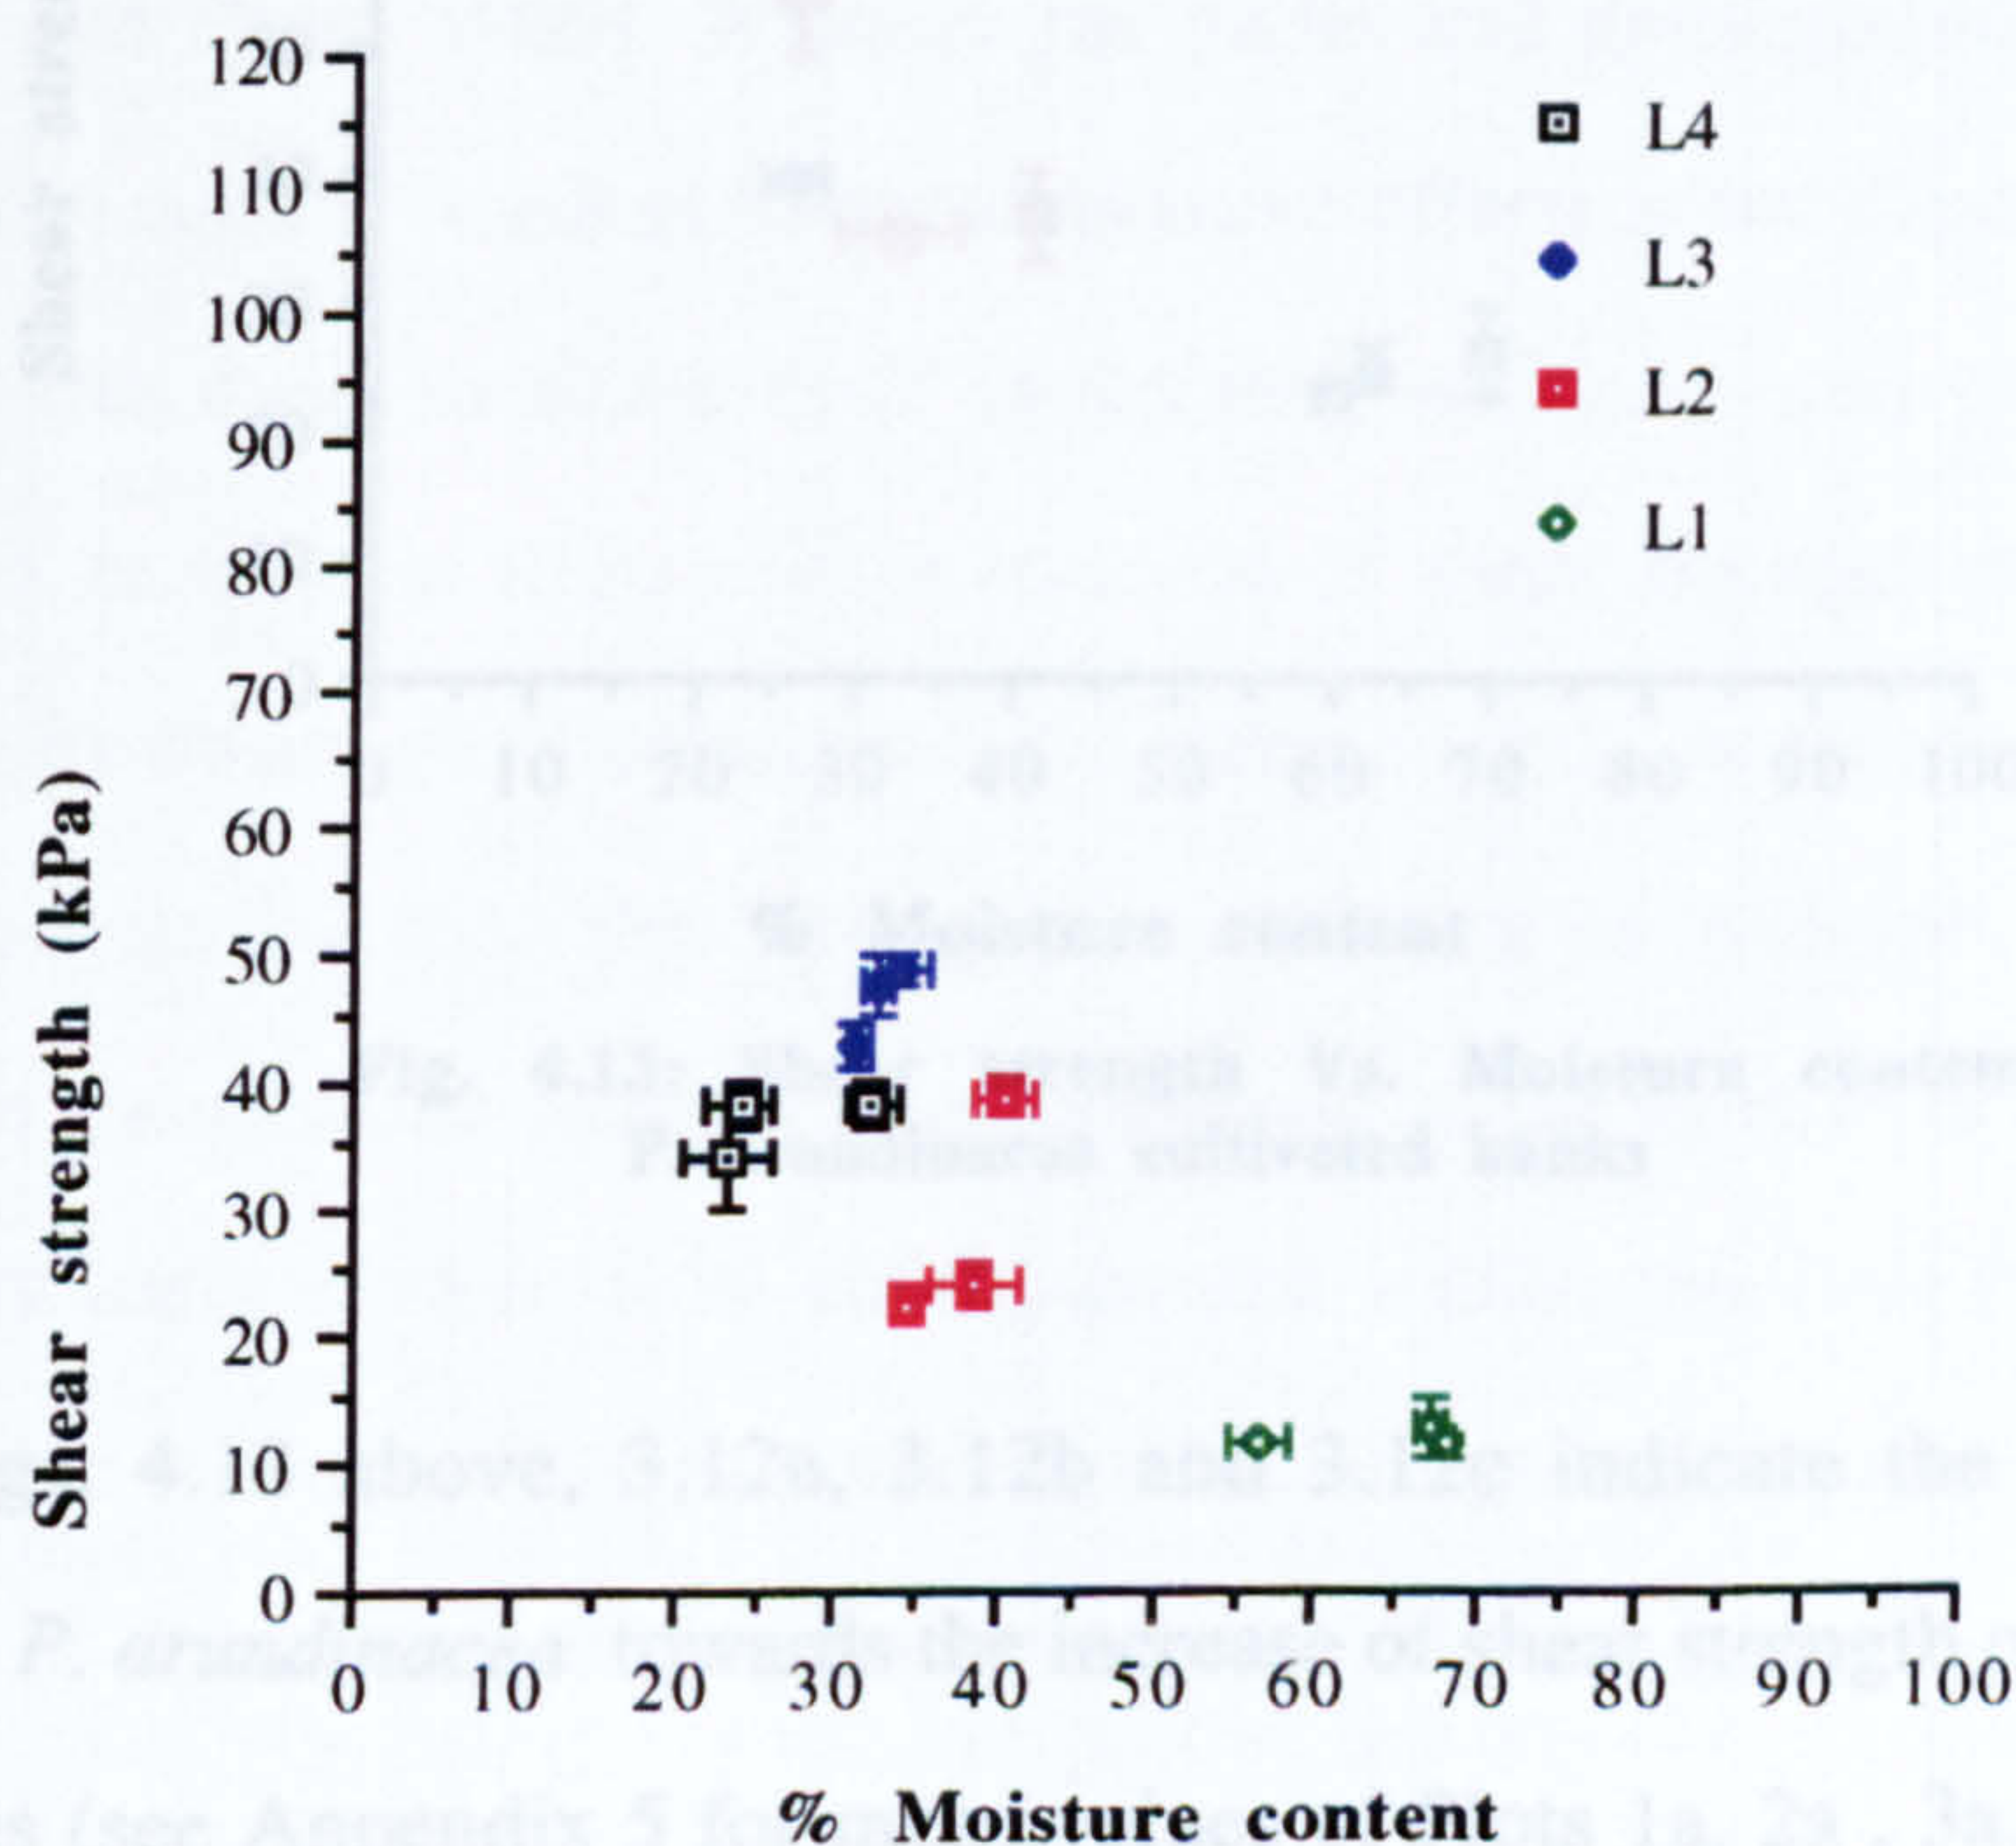
Fig. 4.12: Shear strength Vs. Moisture content variations (May 1988)
***P. arundinacea* cultivated banks**
